# Pheasant Branch Corridor Restoration and Improvements Master Plan

Prepared for  
City of Middleton  
7426 Hubbard Avenue  
Middleton, WI 53562

Prepared by  
Cardno, Inc.  
6140 Cottonwood Dr., Suite A  
Fitchburg, WI 53719  
608 661 2955  
[www.cardno.com](http://www.cardno.com)

February, 2020

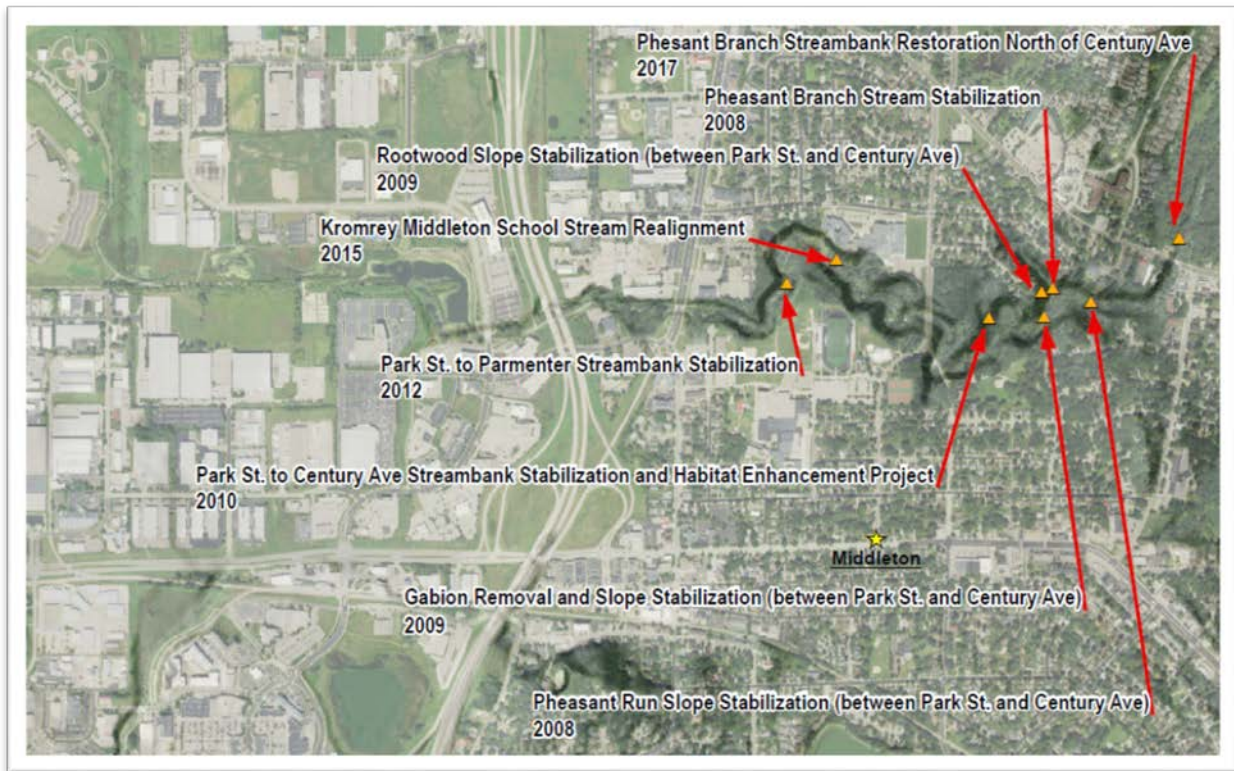
Figure 1: Channel erosion construction project locations within mainstem of Pheasant Branch from 2007-2017.

Eight of these projects were completed along the mainstem of Pheasant Branch from Parmenter Street to the area north of Century Avenue within the City of Middleton (Figure 1).

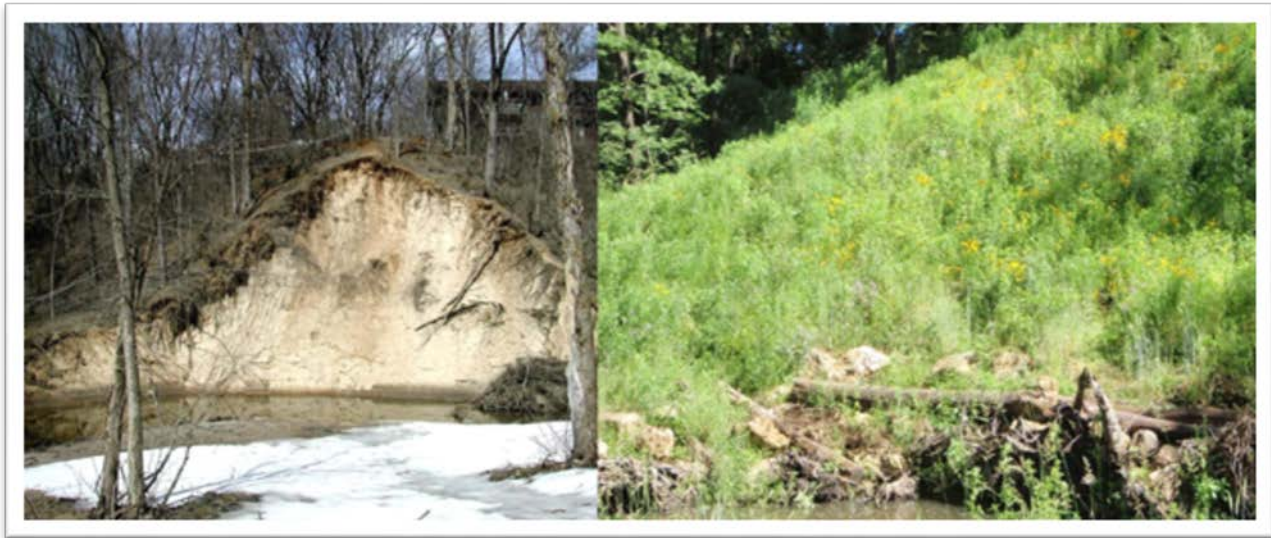
Figure 2: Photo of eroded slope adjacent to Pheasant Branch between Park Street and Century Avenue in 2005 (left) and same slope after construction taken in 2009 (right).

From 2007 to 2010, the City of Middleton performed approximately 2,000 linear feet of streambank and slope stabilization using ecologically-sensitive techniques including rootwad composites to protect the toe of the slopes and create additional deep pool and under-bank habitat. Slope grading was also performed on these slopes to bring them to a more stable angle and once completed the entire project areas were seeded with a mixture of native forbs and grasses. The dense growth and deep root systems of the native vegetation help to hold bank materials in place while allowing water to infiltrate through the soil instead of flowing overland to the stream (Figure 2).

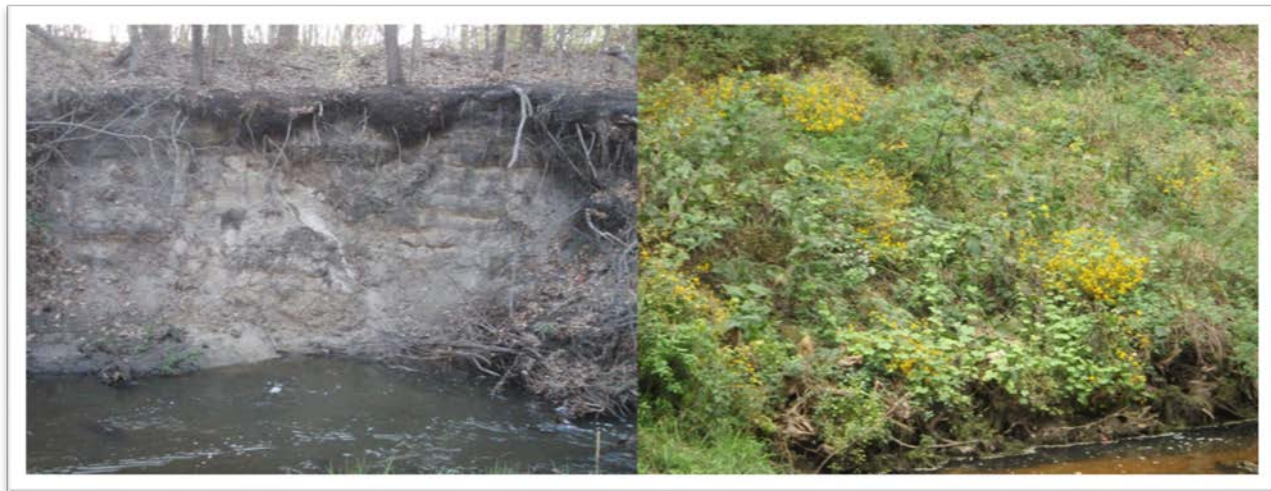
Figure 3: Photo of eroded slope adjacent to Pheasant Branch between Park Street and Parmenter Street in 2010 (left) and same slope after construction taken in 2014 (right).

In 2012, the City of Middleton stabilized nearly 1,500 linear feet of streambanks and slopes between Park Street and Parmenter Street within the Pheasant Branch Corridor using ecologically-sensitive techniques to mitigate erosion. To reduce the sediment load in the creek, stream energy dissipation structures and integrated bank treatments, including rootwad and toewood composites, cross-vanes, and single arm vanes were installed. These methods stabilized the banks while providing improved habitat for the insects, amphibians, reptiles, and fish found within the creek and riparian corridor (Figure 3).

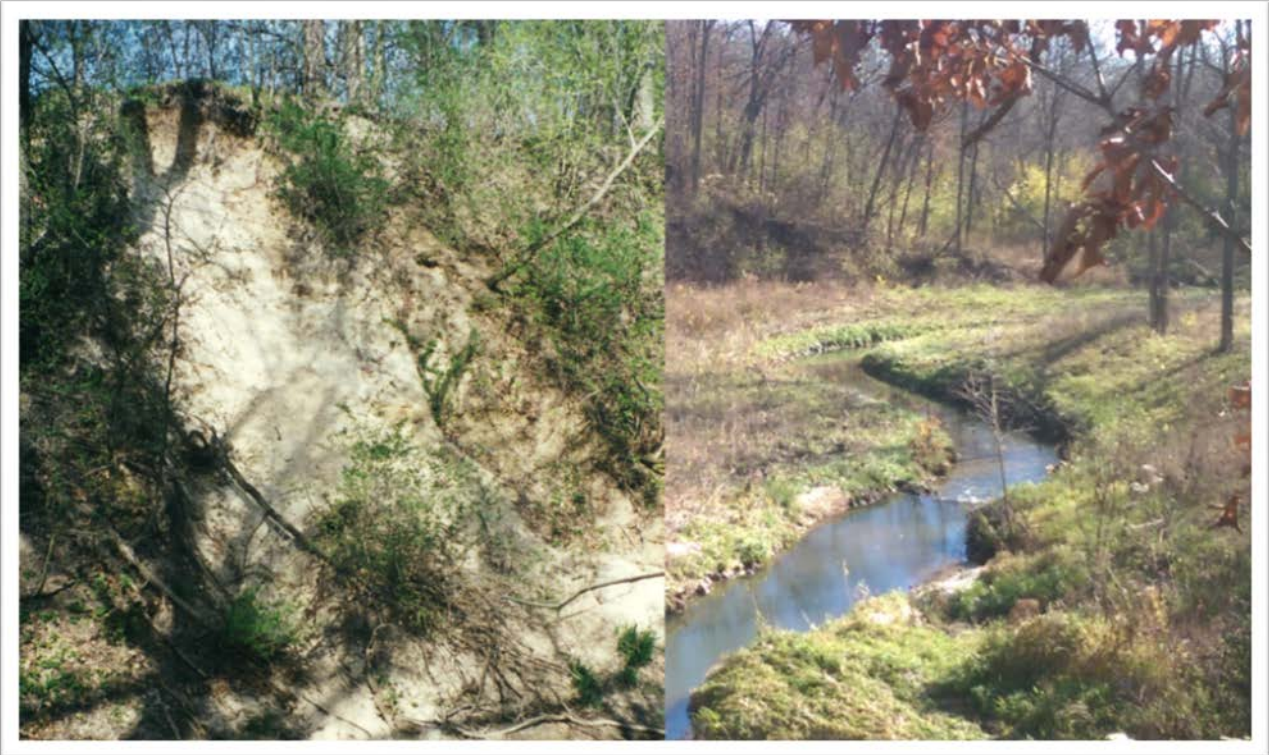
**Figure 4: Photo of collapsing streambank adjacent to Pheasant Branch near site of Kromrey Middle School addition 2013 (left) and same section of stream after construction taken in 2016 (right).**

The Pheasant Branch Kromrey Middle School Stream Relocation Project relocated approximately 500 linear feet of stream channel away from steep eroding slopes and streambanks by creating a new channel using ecologically-sensitive techniques to mitigate erosion. Relocation of this section of stream also increased flood flow capacity at the site allowing flood flows to rise up out of the bankfull channel and spread out over a newly created floodplain, dissipating energy, and offering increased protection at the toe of the steep slope above which a new addition to the Kromrey Middle School was built. As part of the project, an additional 0.04 acres of backwater oxbow wetland was created (Figure 4).

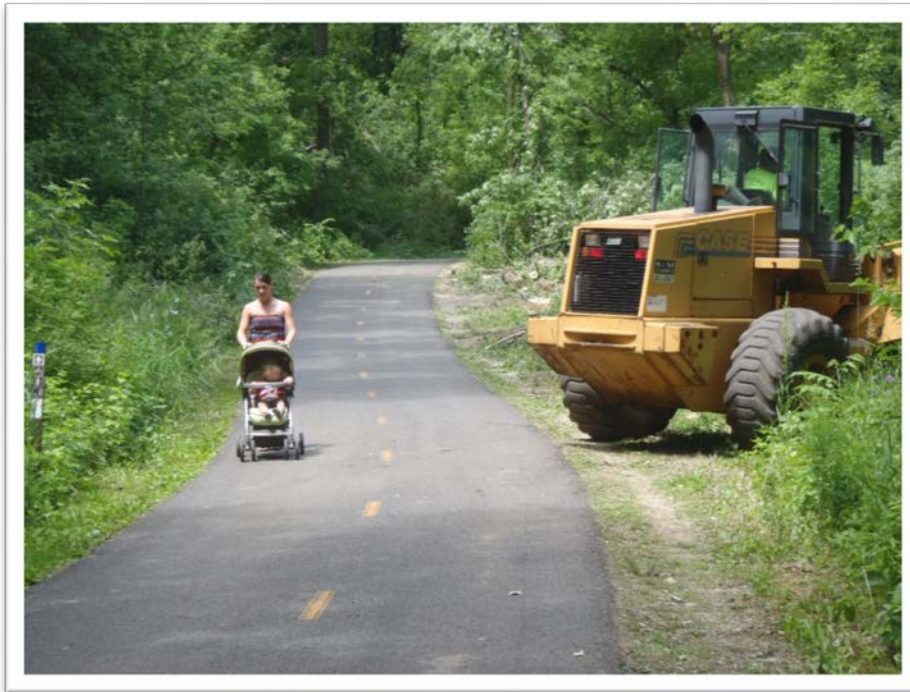
**Figure 5: Photo of Pheasant Branch porous asphalt trail between Parmenter and Park Street (taken 2013).**

In 2009 the City of Middleton performed the Pheasant Branch Corridor Trail project. This project made updates and modifications to the existing trail including paving the corridor trail system with porous asphalt from Parmenter Street to Century Avenue (Figure 5). Additional improvements included installation of three 60-foot, arched bridges between Park Street and Century Avenue (Figure 6). The total cost of this project was \$305,389 of which approximately \$167,970 was covered by a Wisconsin Department of Transportation (WisDOT) grant. Installation of the three bridges in 2009 combined with two existing 60-foot arched bridges installed in 2007 between Parmenter Street and Park Street made a total of five bridges on stream crossings within the corridor (an additional sixth, 65-foot bridge, was added in 2016).

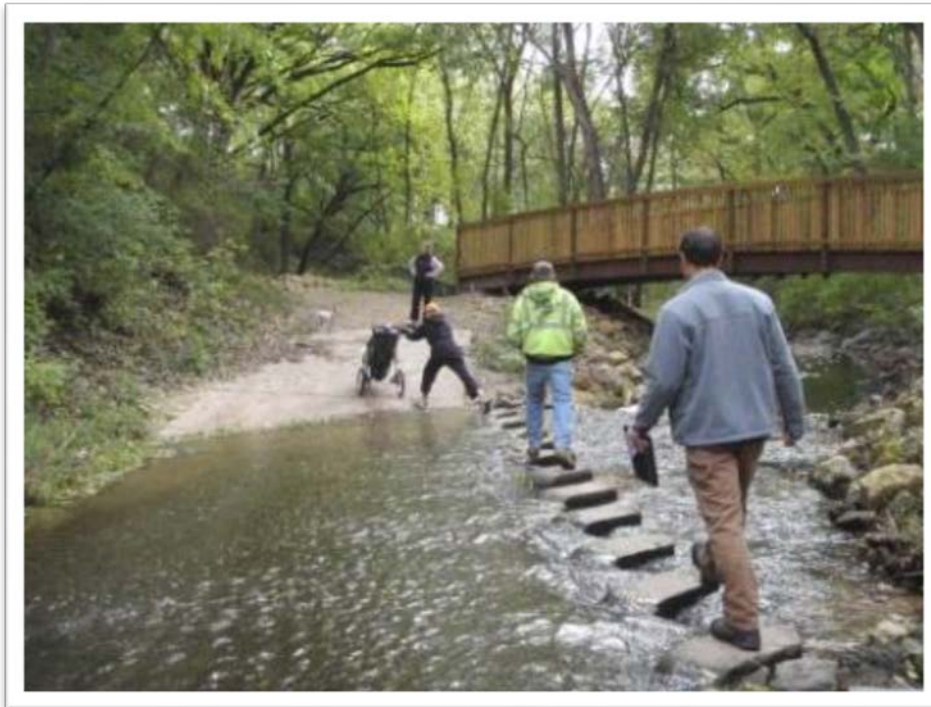
**Figure 6: Photo of pedestrian bridge in Pheasant Branch Corridor between Park Street and Century Ave (taken 2013).**

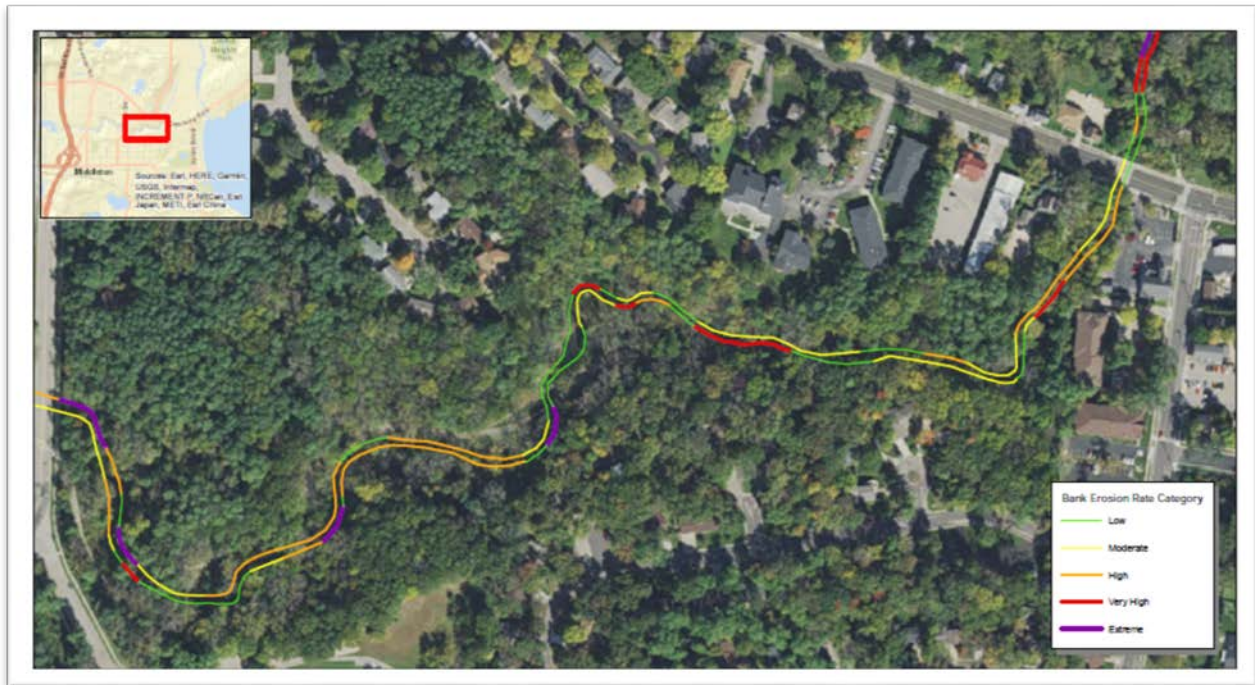
**Figure 9: BEHI model streambank erosion risk assessment for mainstem of Pheasant Branch between Park Street and Century Avenue**

Cardno performed a complete streambank erosion assessment of both the left and right bank for the north fork, south fork and mainstem of Pheasant Branch. Streambank erosion assessments were performed using the Bank Erosion Hazard Index (BEHI) model developed by Dr. David Rosgen<sup>3</sup>. The BEHI model evaluates the susceptibility of a streambank to erosion for multiple erosional processes. Individual BEHI variables are recorded through visual assessments and physical measurements to determine the combined risk for specific streambank sections to future streambank erosion (Figure 9).

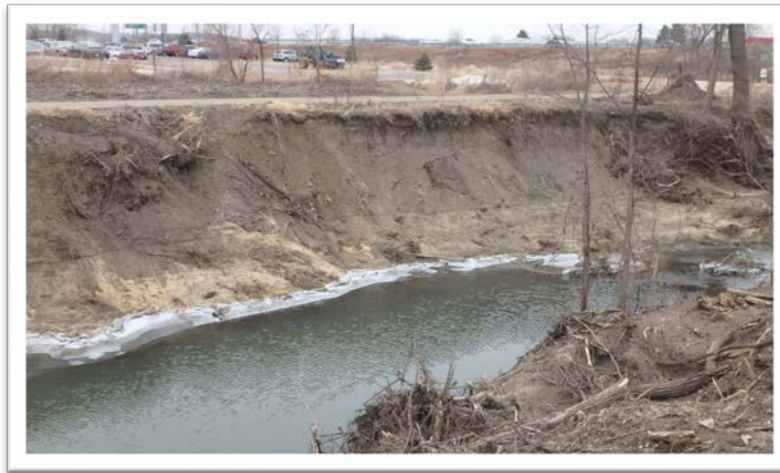
**Figure 10: Extreme streambank erosion as a result of August 2018 flood event near Deming Way viewing downstream (1/15/19).**

Some areas of the mainstem of Pheasant Branch between the confluence pond and Parmenter Street did experience various degrees of bank erosion following the August 2018 flood event. Streambank assessments within this area determined that approximately 1,520 linear feet of streambanks showed High bank erosion rates with an additional 197 linear feet exhibiting Very High and 264 linear feet of Extreme streambank erosion (Figure 10).

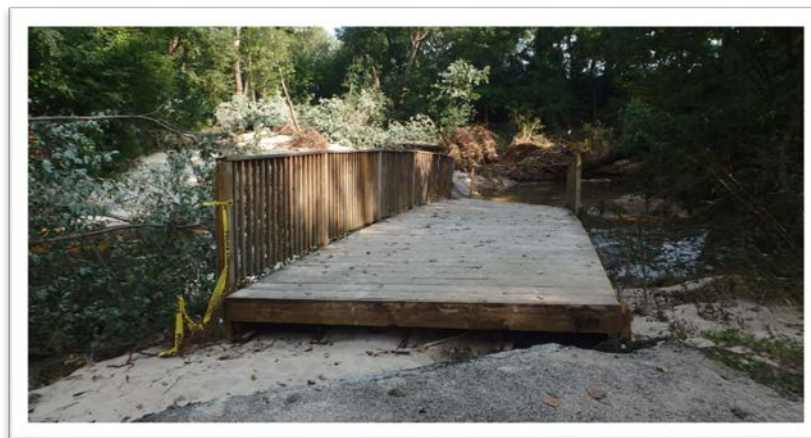
**Figure 11: Photo of damaged bridge near Parmenter Street following August 2018 flood viewing downstream (8/25/18).**

The mainstem of Pheasant Branch between Parmenter Street and Park Street experienced significant damage following the August 2018 flood event. All three pedestrian bridges that cross the channel between Parmenter Street and Park Street were damaged (Figure 11).

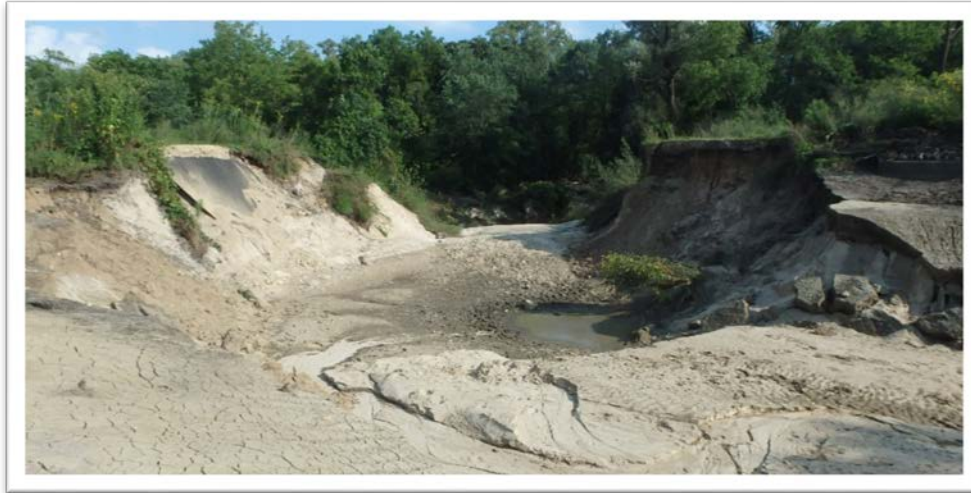
**Figure 12: Photo of Donna Dr. sedimentation pond failure following August 2018 flood event (8/25/18).**

Extensive damage also occurred at the Donna Drive sedimentation pond where flood waters overtopped the pond, eroding the pond bank, causing a complete failure of the pond and stream embankment (Figure 12).

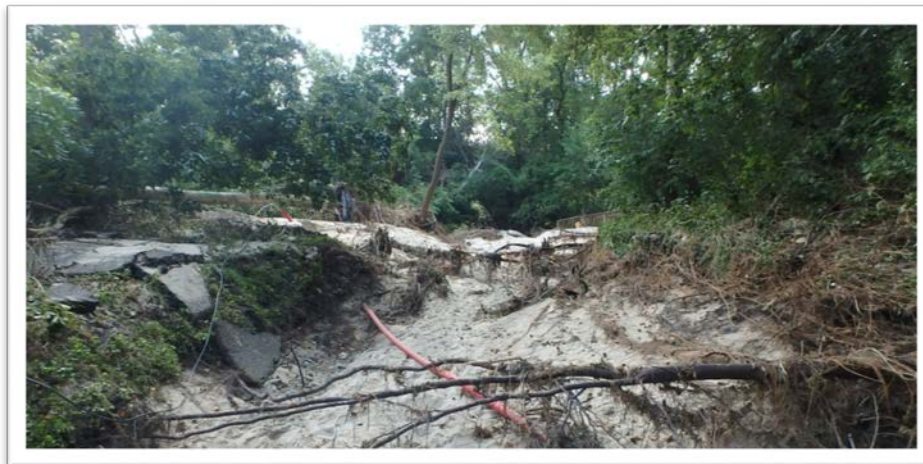
**Figure 13: Photo of pedestrian trail damage between Parmenter Street and Park Street following August 2018 flood event (8/25/18).**

Much of the damage to the existing bridges and streambanks in this section was caused by debris jams consisting of mainly shallow rooted tree species that collapsed into the stream during the August 2018 flood event. Streambank assessments performed through this reach identified approximately 3,892 linear feet of streambanks showing evidence of High bank erosion with 453 linear feet of Very High and 625 linear feet of Extreme streambank erosion. Much of the pedestrian trail system adjacent to Pheasant Branch was also damaged during the August 2018 flood event. These areas will also need to be repaired along with restoration of streambanks and the stream channel in this section of Pheasant Branch (Figure 13).

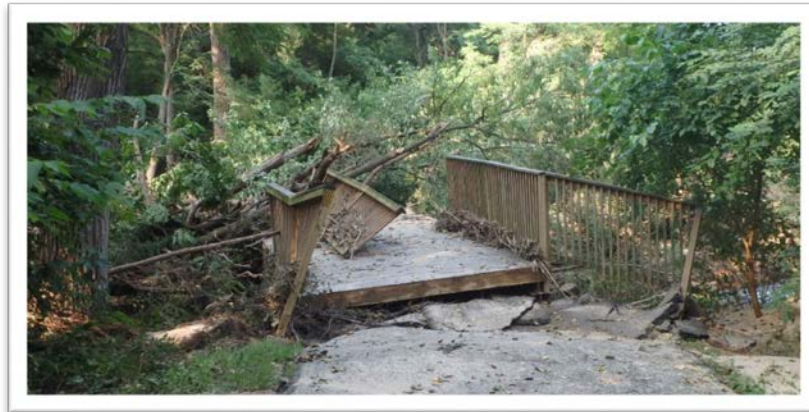
**Figure 14: Photo of damaged pedestrian bridge between Park Street and Century Avenue following August 2018 flood event (8/25/18).**

The mainstem of Pheasant Branch between Park Street and Century Avenue experienced significant damage during the August 2018 flood event including damage to each of the three pedestrian bridges located in this section of stream (Figure 14).

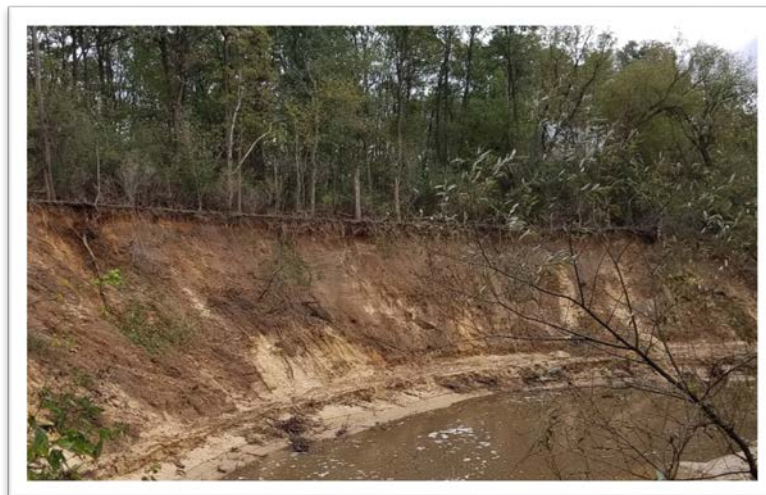
**Figure 15: Photo of extreme streambank erosion directly downstream of Park Street as a result of August 2018 flood event (10/11/18).**

The public trail system within this section was also damaged and well as multiple areas of significant streambank erosion. Streambank erosion assessments within this reach found that approximately 2,289 linear feet of streambank showed evidence of High bank erosion with 503 linear feet of Very High and 444 linear feet showing evidence of Extreme streambank erosion. Much of the damage to bridges and streambanks in this section was caused by debris dams comprised of shallow rooted trees that collapsed into the channel during the August 2018 flood event. Extreme streambank erosion also occurred directly downstream of the Park Street crossing as flood flows we concentrated through the culverts running beneath the roadway (Figure 15).

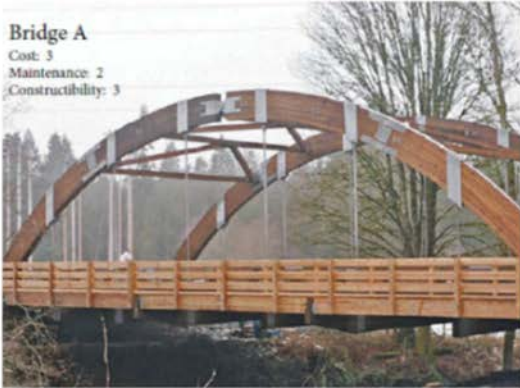
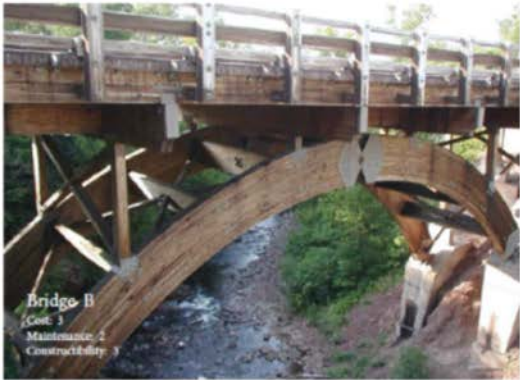
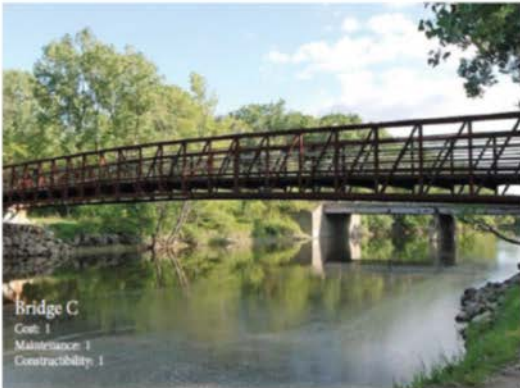
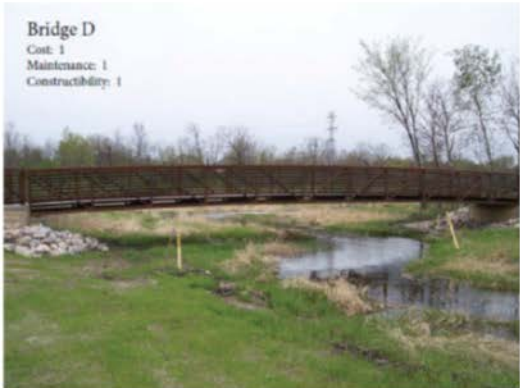
**Figure 30: Bridge design preference poll photos**

The highest scored example was a pre-fabricated bike/pedestrian bridge in a weathered Steel Pratt Truss style. (Both C & D were variations of this type).

Public Input was gathered relative to the bridge type. Examples were shown that then scored each type based on cost, maintenance, and constructability (Figure 30).

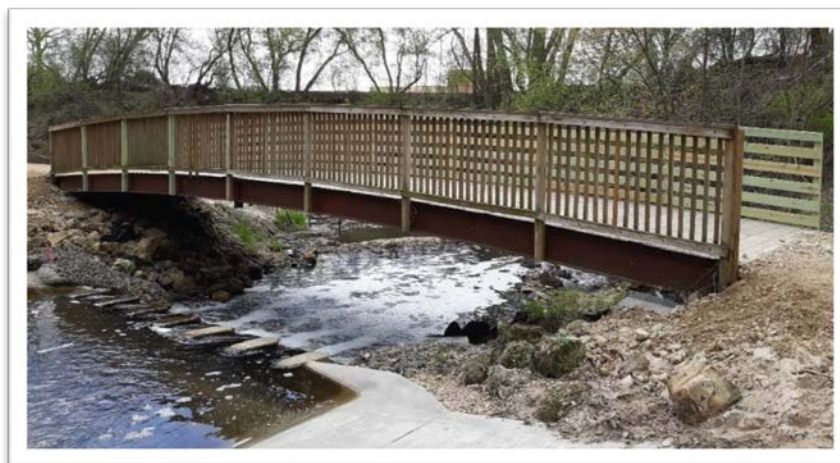
This 60-foot long arched bridge was installed in 2007 with a 12,000 pound design load. It has a 12-foot clear width between railings and the railing height is 54 inches. Bridge #1 has a substructure that sits on galvanized sill pans that rest on an incised channel. A vehicle crossing with a significant drop is located directly upstream of the bridge which creates a larger channel slope and capacity through bridge (Figure 38). Hydraulic modeling results show that the floodplain is not activated until the 100-year discharge. Water surface reaches the bottom of the beam (low chord) by the 50-year flood discharge, but the bridge deck does not overtop even during the 100-year flood discharge.

**Figure 38: Upstream face of Bridge #1**

All bridges but Bridge #3 (trail spur to middle school) have concrete vehicle crossings with baffle blocks/steps either directly upstream or downstream of the bridge and vehicle crossings and crossing configuration can have important effects. For example, Bridge #1 has both a weir and a vehicle crossing with a steep drop upstream of the bridge, resulting in higher channel slope and hydraulic capacity underneath the bridge and lower flood risk to the bridge. Conversely, Bridge #2 has a vehicle crossing downstream of the bridge, and scour between the bridge and the vehicle crossing has resulted in adverse local channel slope and lower channel hydraulic capacity underneath the bridge. As a result, the bridge low chord is impacted at the 10-yr event despite having a very well connected adjacent floodplain (connected at the 2-yr).

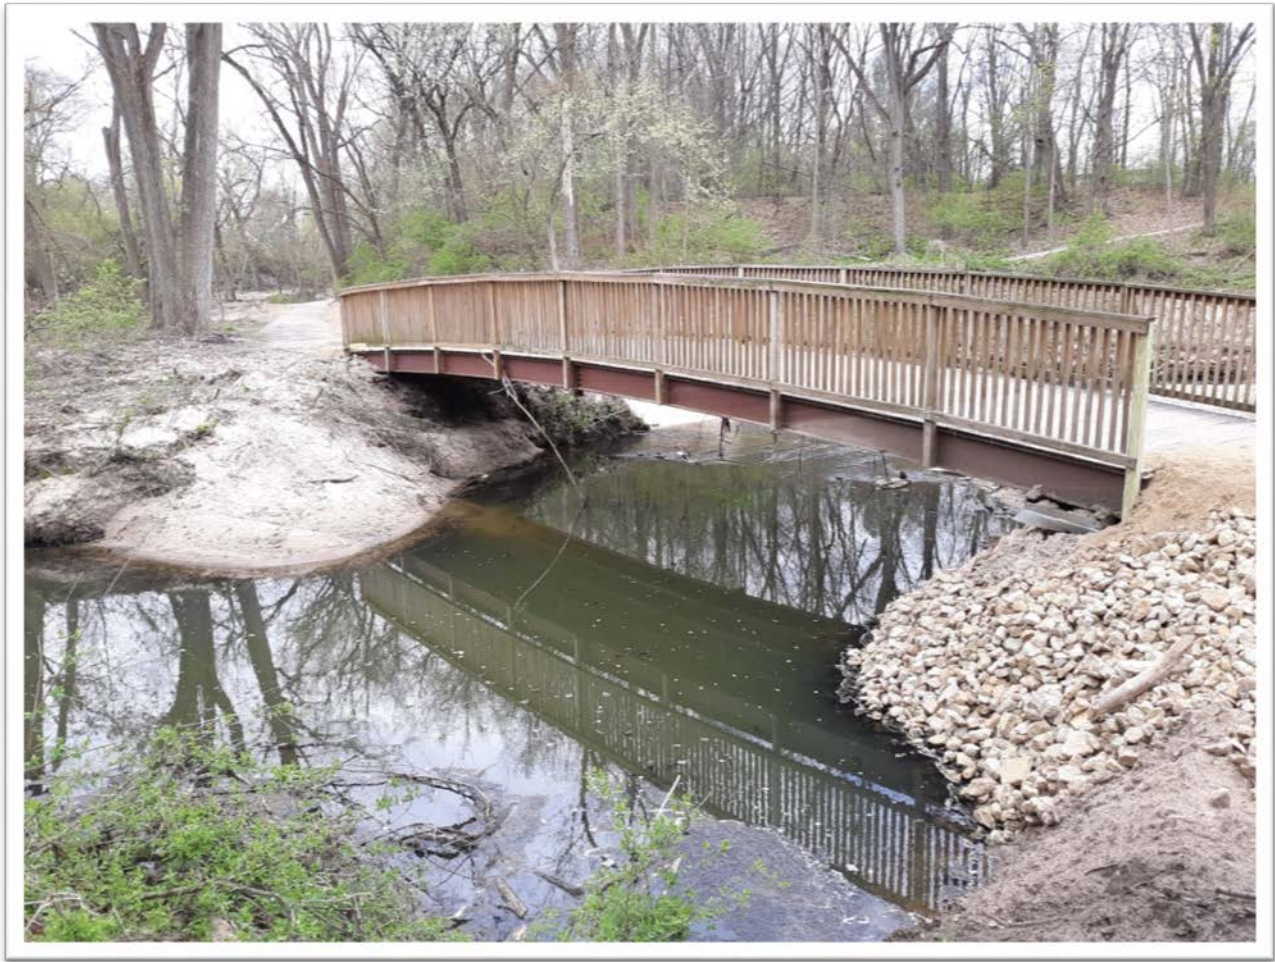
Bridge #2 is a 60-foot long arched bridge installed in 2007 with a 12,000 pound design load. It has a 12-foot clear width between railings, a railing height of 54 inches, and has a substructure that sits on galvanized sill pans. It is located directly downstream of a tight bend in the stream and there is a vehicle crossing with a significant drop located directly downstream of the bridge (Figure 39). Bridge #2 has been placed in a section of channel with a low floodplain bench that activates by the 2-year discharge. The low chord of the bridge is reached by water at the 10-year discharge because the bridge is set fairly low on the streambanks and the downstream vehicle crossing is creating lower hydraulic channel capacity. The bridge deck is not overtopped until the 50-year discharge.

**Figure 39: Upstream face of Bridge #2**

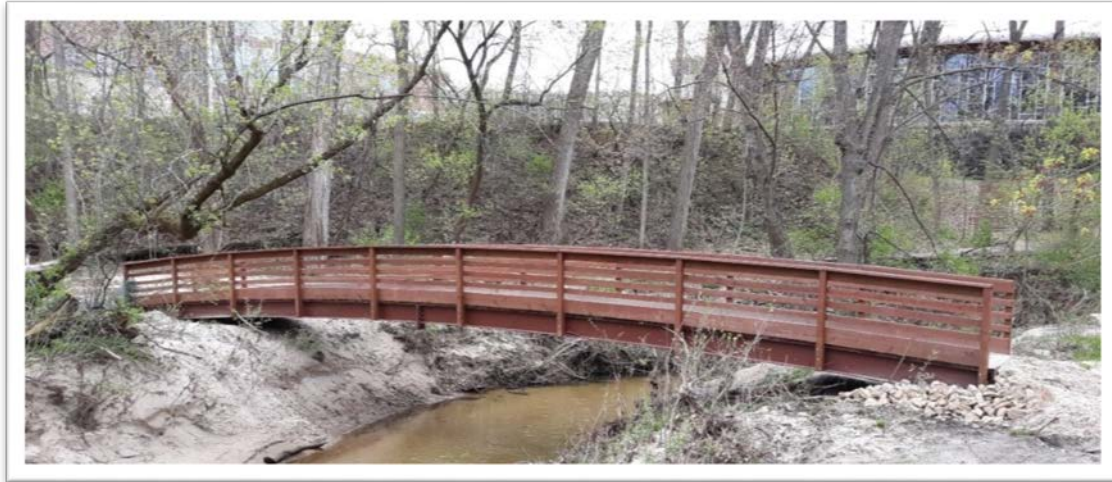
This 65-foot long arched bridge was installed in 2016 and has a substructure that sits on galvanized sill pans. The design load is noted as 30 pounds per square foot (psf) and then 10,000 pounds at mid-span. It has a 6-foot clear width between railings and the railing height is 42 inches (Figure 40). Bridge #3 has been placed in a section of meandering channel with a low floodplain bench that activates by the 5-year discharge. Hydraulic modeling results show the water surface reaching the bottom of the beam (low chord) by the 10-year flood discharge, and the bridge deck is overtopped at the 25-year discharge.

**Figure 40: Upstream face of Bridge #3**

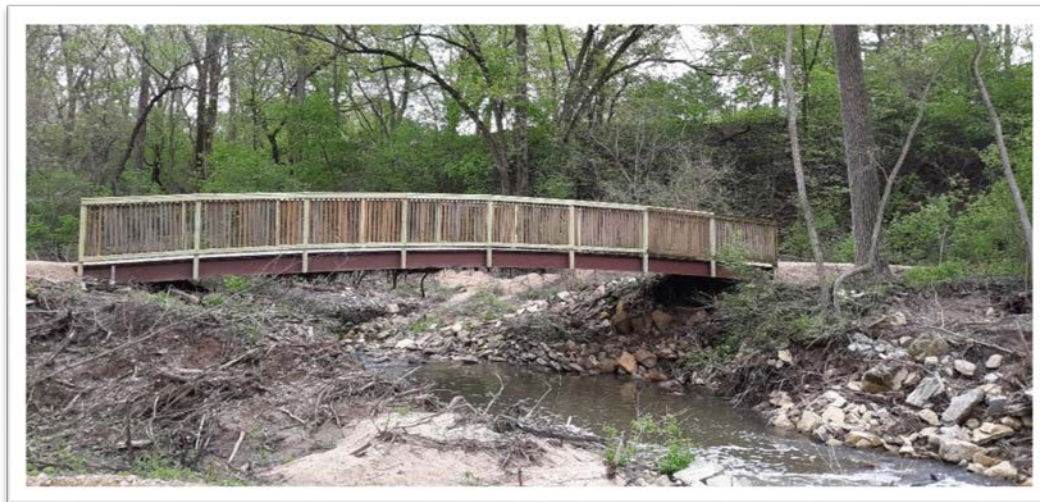
Bridge #4 is a 60-foot long arched bridge installed in 2009 with a 12,000 pound design load. It has a 12-foot clear width between railings, a railing height of 54 inches, and has a substructure that sits on galvanized sill pans that rest on an incised channel (Figure 41). A vehicle crossing is located upstream of the bridge. Hydraulic modeling results show that the floodplain is activated and water reaches the low chord of the bridge by the 50-year discharge. The bridge deck is not overtopped by the 100-year flood discharge.

**Figure 41: Upstream face of Bridge #4**

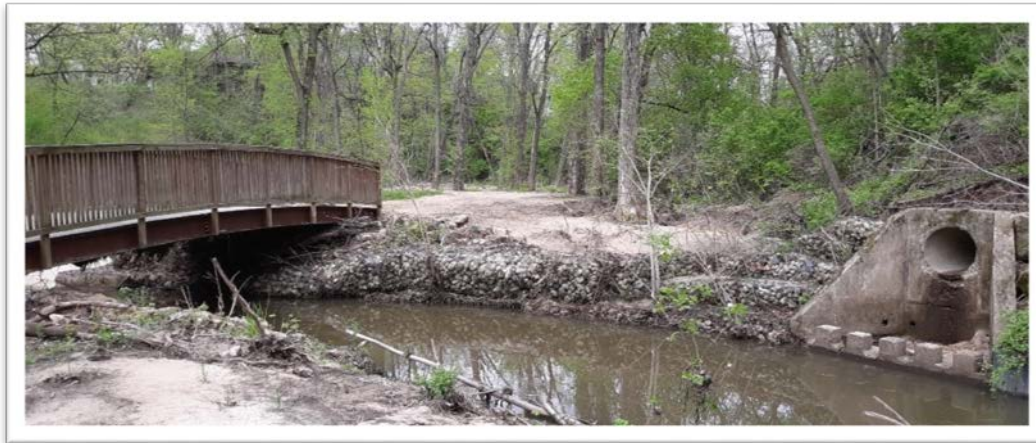
This 60-foot long arched bridge was installed in 2009 with a 12,000 pound design load. It has a 12-foot clear width between railings and the railing height is 54 inches. Bridge #5 has a substructure that sits on galvanized sill pans (Figure 42). Bridge #5 has been placed in a section of channel with a wide floodplain bench that activates by the 10-year discharge. The low chord of the bridge is not reached by water until the 25-year discharge and the bridge deck is not overtopped until the 100-year flood discharge. This section of channel also experiences high flow velocities during the 100-year discharge. A vehicle crossing is located directly downstream of the bridge and a stormwater outflow is located directly upstream. Hydraulic modeling results show the bridge deck is overtopped at the 100-year discharge.

**Figure 42: Upstream face of Bridge #5**

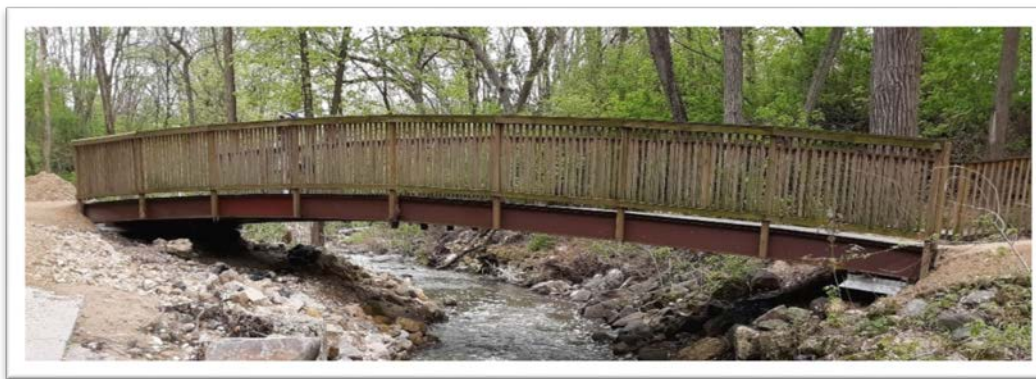
Bridge #6 is a 60-foot long arched bridge installed in 2009 with a 12,000 pound design load. It has a 12-foot clear width between railings, a railing height of 54 inches, and has a substructure that sits on galvanized sill pans (Figure 43). Bridge #6 has been placed in a narrow section of channel, low on the banks. A vehicle crossing is located directly upstream of the bridge. Hydraulic modeling results show the water surface reaches the bottom of the beam (low chord) at the 25-year flood discharge, the floodplain is activated by the 50-year, and the bridge deck is also overtopped by the 50-year flood discharge which means the bridge deck is overtopped before stream flows reach the floodplain. This bridge section also experiences the largest velocities of any of the six bridge locations during the 100-year flood discharge.

**Figure 43: Upstream face of Bridge #6**

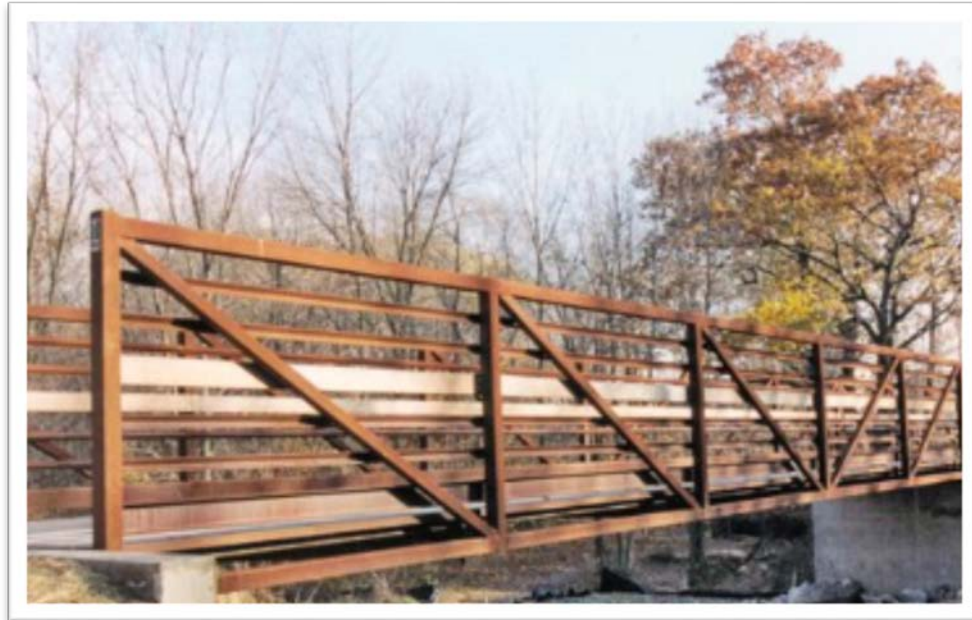
The 54" height typically has the negative elements that the taller height causes difficulties with view shed and posture for viewing (for both adults and youth). The 42" allows for better view sheds, but the comfort level for safety of bicyclists is sometimes diminished. Based on these considerations, we recommend that all railing is designed to a 48" height with rub-rail to serve secondarily as a handrail (Figure 47).

**Figure 47: Example bridge railing style**

With longevity and maintenance a concern within the corridor, timber railings also are not as desirable (warping & vandalism). We recommend utilizing the weather steel for the majority of the railing and then supplementing with a timber rub-rail to serve secondarily as a handrail.

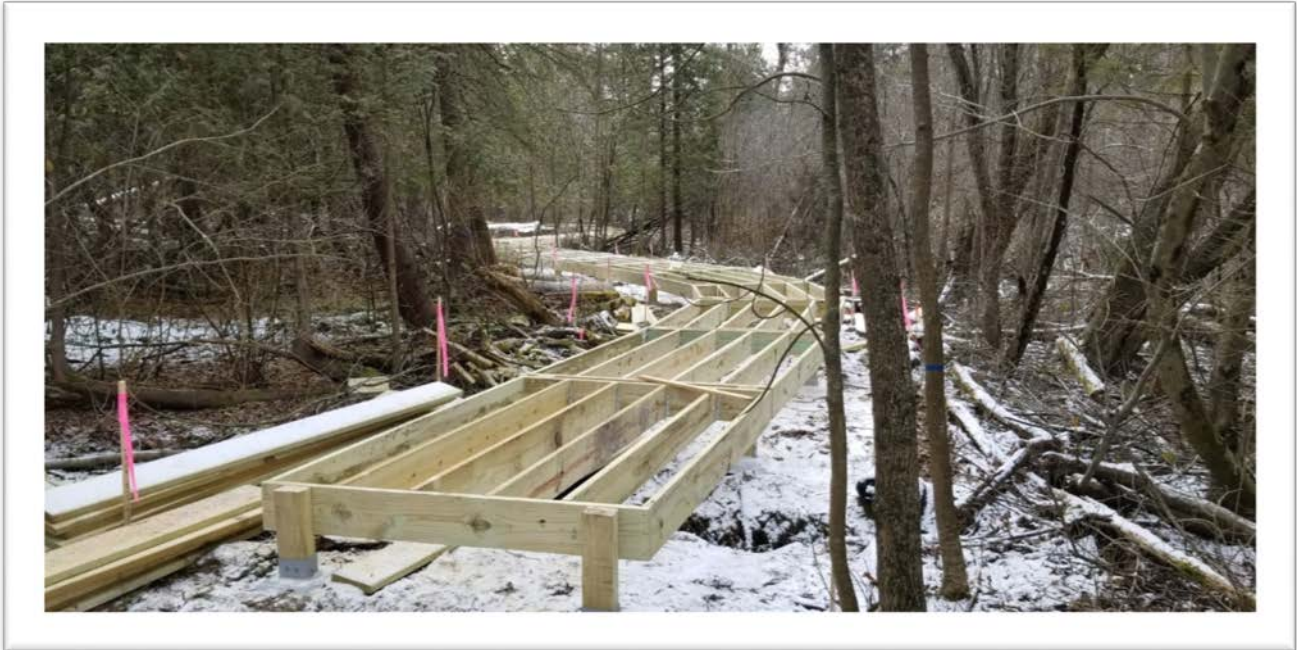
**Figure 48: Example Bridge Pan style substructure. Pans are located at each of the posts on the snow**

A galvanized base pan is a pad partially embedded into suitable native soil. The Pan System “floats” (partially imbedded) on top of the existing surface and in bridge situations has an additional anchor in place for added stability. The superstructure of the bridge then “sits” on these pans.

The existing bridges are currently supported by a “Pan” system substructure. In this section, we’ll detail the typical options for substructure of bicycle/pedestrian bridges (Figure 48).

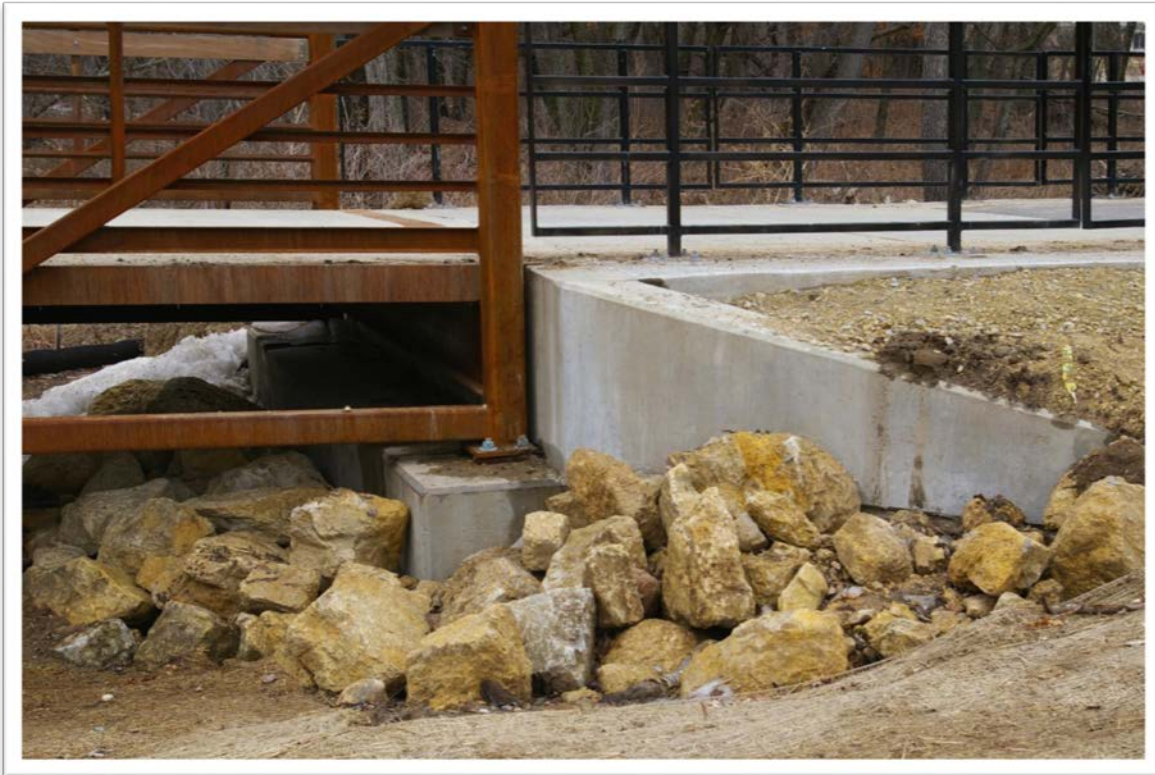
Spread footings are generally used where the soil can sustain reasonable pressures without excessive settlement. Additionally, these are also typically used where there is no worry of scour nor soil erodibility and there are not sensitive environments surrounding them as they typically require the greatest disturbance area (Figure 49).

**Figure 49: Example bridge concrete footing abutment substructure**

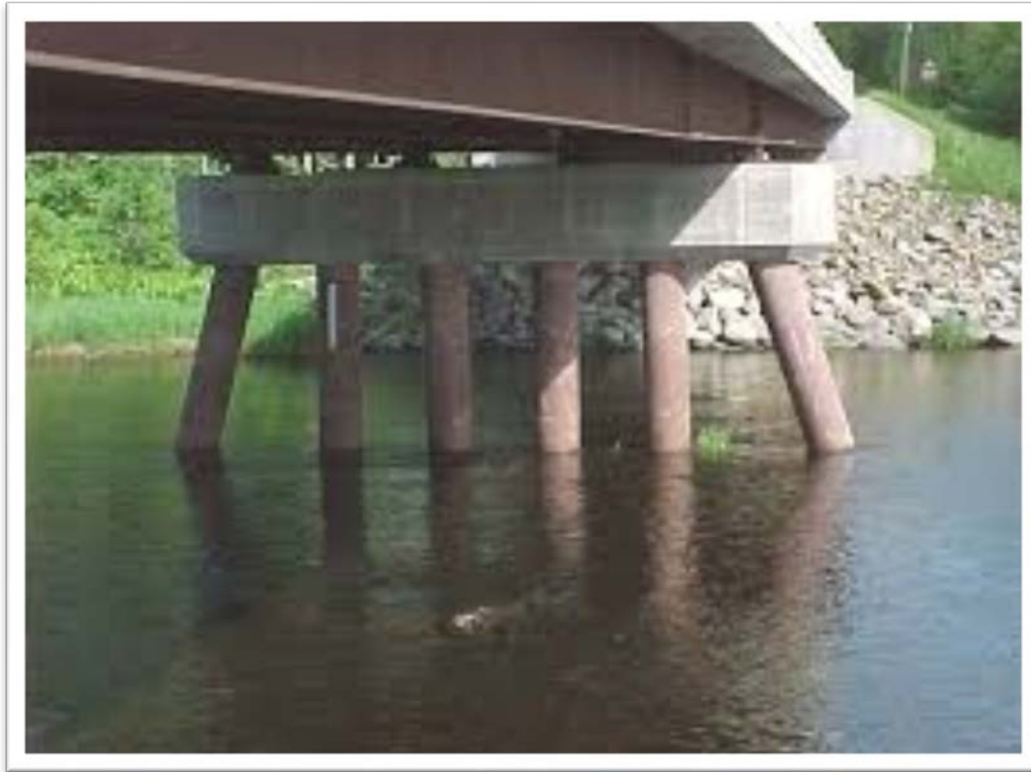
Pile foundations utilize driven piling to support a reinforced concrete abutment. This creates a solid base for construction, with no anticipated movement related to freeze/thaw or loads. This deep foundation type is typically resistant to scour issues from flooding events (Figure 50).

**Figure 50: Example bridge bent pile pier substructure**

Understanding that geotechnical investigations, final bridge design elements, and hydraulics will be critical to actual design, we would typically recommend the use of pile supported abutments for this site.

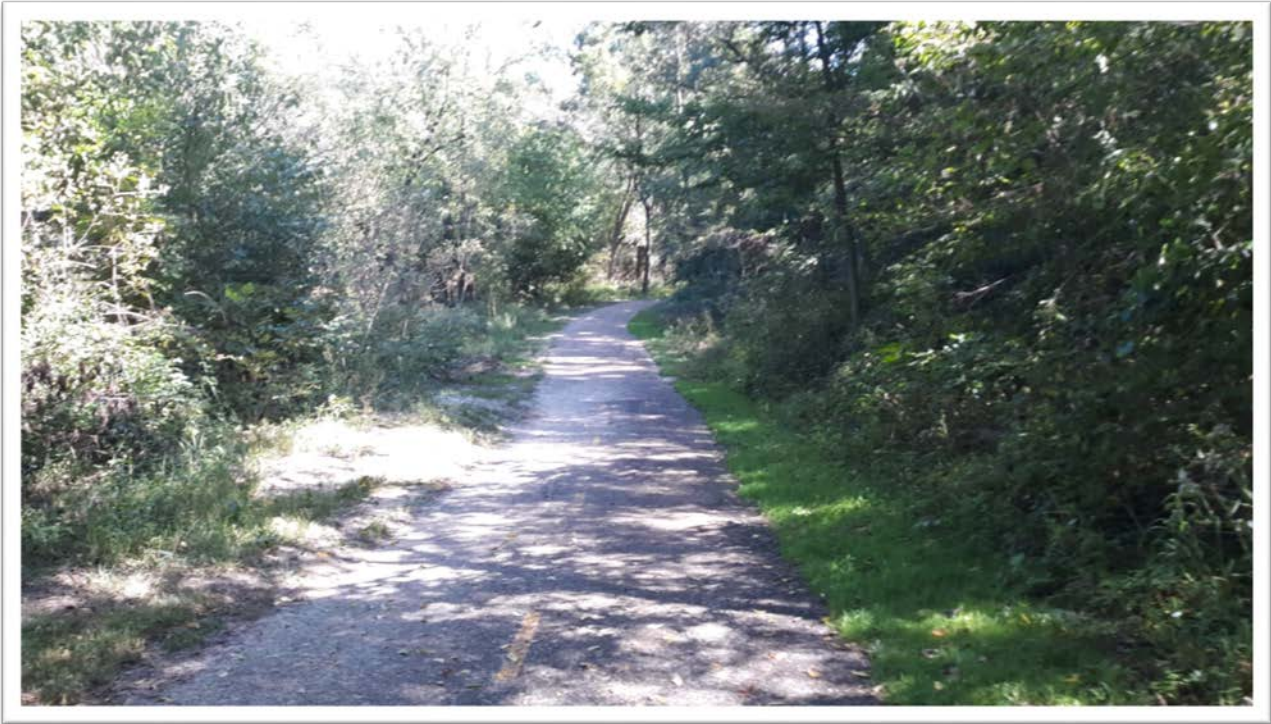
The current alignment of the trail is dependent on the existing topography and the stream alignment. The trail is currently 10' wide porous asphaltic pavement with 2-3' stone shoulders that are largely grown in with vegetation (Figure 51).

**Figure 51: Photo of existing trail within Pheasant Branch Corridor**

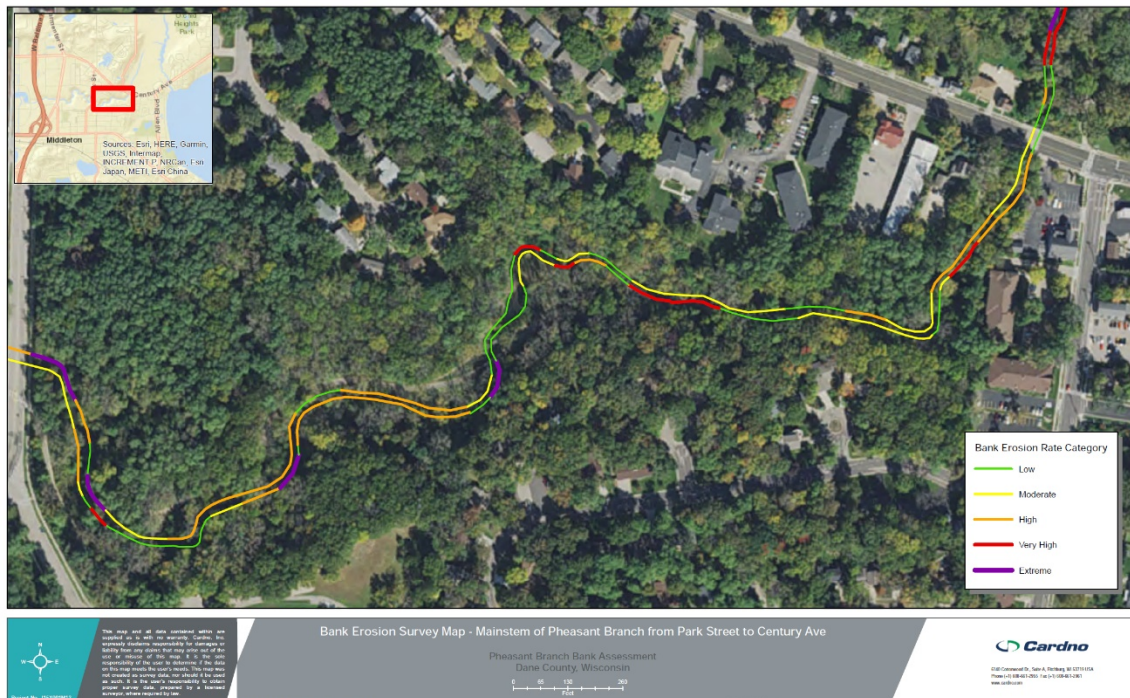
Figure 61: Location of streambank restoration areas identified between Park Street and Century Avenue

Restoration of the streambanks in the Pheasant Branch Corridor will focus on these areas as they pose a high risk to public and private property. Areas identified for restoration are shown in Figures (59, 60 and 61).

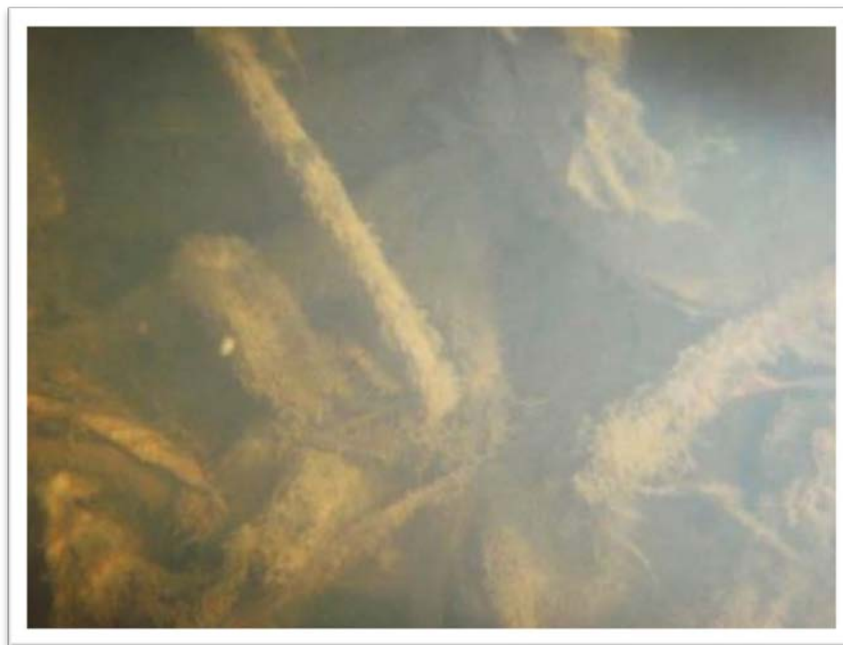
Areas of active streambank erosion throughout the Pheasant Branch Corridor vary in size, extent of active erosion, and in applicable treatments. In many cases, eroded slopes and streambanks could be repaired through the use of integrated bank treatments including rootwads composites and/or toewood (Figure 62).

Figure 62: Underwater photo take of installed rootwad composite (8/20/12)
