# Pheasant Branch Corridor Restoration and Improvements Master Plan

Prepared for  
City of Middleton  
7426 Hubbard Avenue  
Middleton, WI 53562

Prepared by  
Cardno, Inc.  
6140 Cottonwood Dr., Suite A  
Fitchburg, WI 53719  
608 661 2955  
[www.cardno.com](http://www.cardno.com)

February, 2020

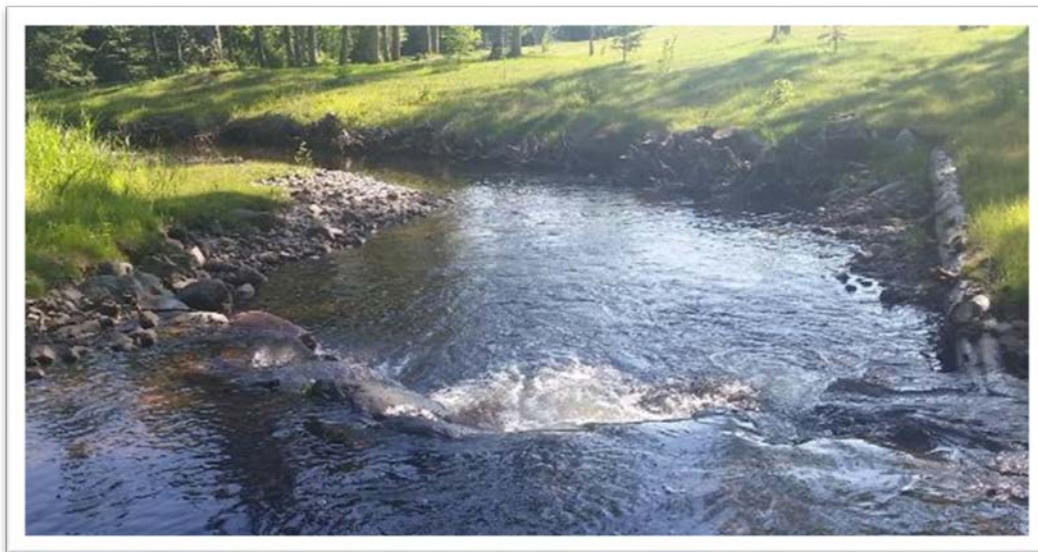
Cross vane grade controls and flow redirection structures such as single arm vanes and J-Hooks can be used to deflect stream flow away from the streambank toward the center of the channel mitigating bank erosion at sites within the project areas. Flow deflection structures (including single arm vanes, cross-vanes and J-Hooks) have been utilized under various channel conditions for over 30 years throughout most regions of the U.S. There is a large volume of technical information regarding field applications and hydraulic research related to these structures. Once installed, these structures induce deposition in near-bank areas while accelerating flows back toward the center of the channel creating scour pools essentially transforming areas of erosion into areas of deposition, further protecting the toe of the streambank. Trees procured during restoration activities could also be incorporated into the flow redirections structures in order to create addition in-stream and under-bank habitat while providing grade control (Figure 64).

**Figure 64: Example of rootwad log vane J-hook combination installed by Cardno on the Knife River in 2016 near Two Harbors, MN**

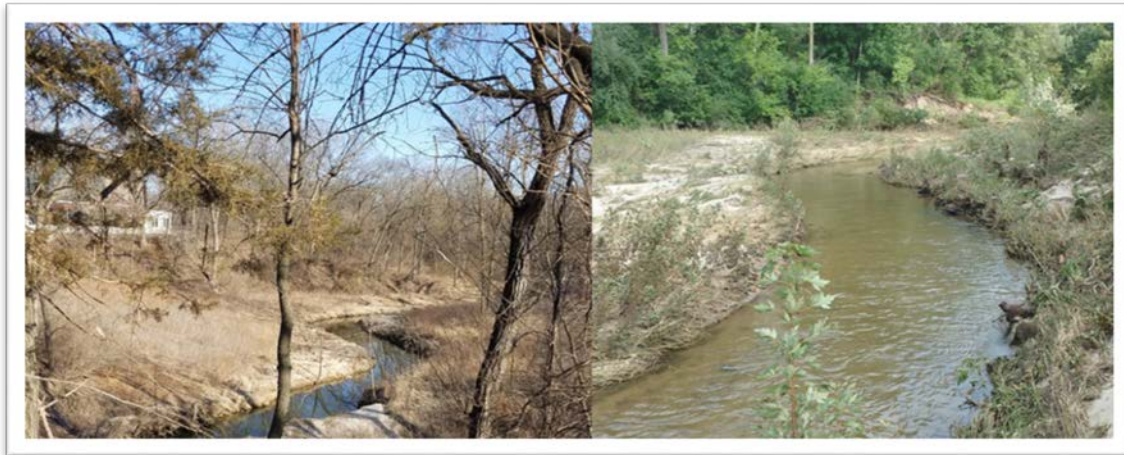
The rainfall event on August 20, 2018 (into the morning of August 21) was one of, if not the largest rainfall events ever recorded in the State of Wisconsin over a 24 hour period. There were, however, some areas within the Pheasant Branch Corridor that made it through this flood event with very little bank erosion and/or damage to steep slopes. One of the areas that made it through the August 2018 flood event with little damage was approximately 500 linear feet of relocated channel near the Kromrey Middle School constructed in 2015. Relocation of this section of stream between Parmenter Street and Park Street increased flood flow capacity at the site allowing flood flows to rise up out of the bankfull channel and spread out over a newly created floodplain area to dissipate stream energy while offering increased protection at the toe of the steep slope above which a new addition to the Kromrey Middle School was built (Figure 65).

**Figure 65: Photo of relocated section of Pheasant Branch in 2017 (left) and same section of stream less than a week after flooding taken on 8/25/18 (right).**

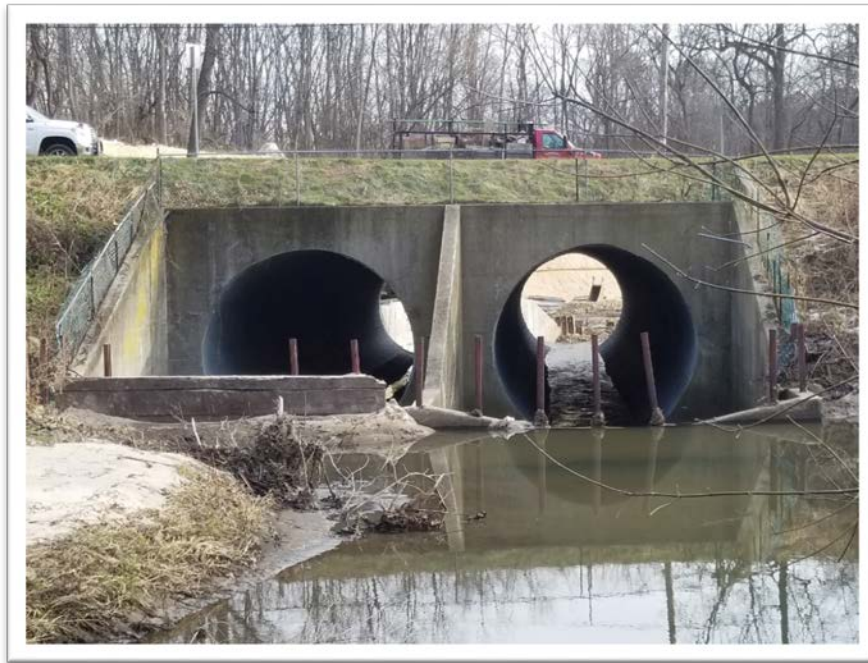
A drop structure and two large culverts at the stream crossing underneath Park Street currently act as a barrier to upstream migration of fish in the mainstem of Pheasant Branch. Retro-fitting with fish passage structures to aid fish passage over and through the current barrier or replacement of the current crossing with a bridge would eliminate this barrier (Figure 67). Replacement with a bridge would also increase flood flow capacity through this crossing which would need to be accounted for in designs. The existing drop structure also currently provides grade control at this location. Installation of grade control structures that still provide fish passage would also be necessary if the current structure was removed to mitigate destabilizing channel adjustments.

Figure 67: Photo of Park Street fish barrier

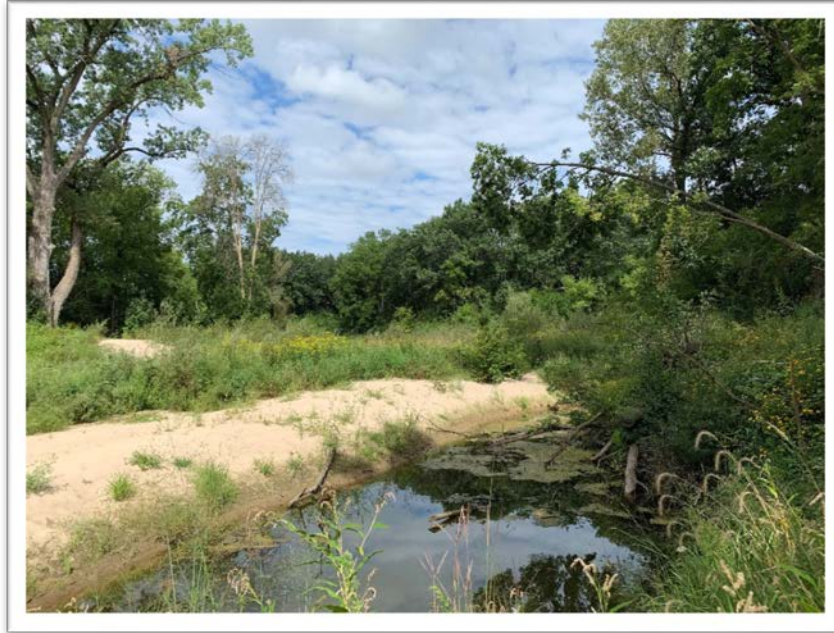
The sand prairie restoration is proposed for areas that received large deposits of sand from the 2018 flood. In some areas, several feet of sand were deposited on the existing vegetation (Figure 70).

**Figure 70: Areas of significant sand deposition by the 2018 flood. Rather than remove the sand, these are excellent opportunities for restoration of sand prairie and other sand-dependent ecosystems within the corridor.**

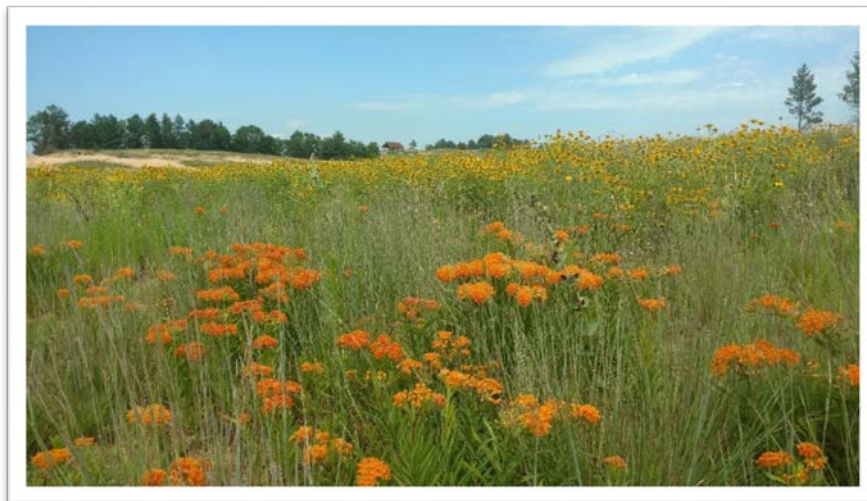
Rather than remove the sand, these are excellent opportunities for restoration of sand prairie and other sand-dependent ecosystems within the corridor. Because clearing is proposed and these areas will rarely be inundated, it is appropriate to propose a sand prairie restoration here. Restoration would consist of clearing the invasive vegetation and re-seeding with sand prairie and sand-dependent species (Figure 71).

**Figure 71: Restored sand prairie two growing seasons after seeding. Site was a former pine plantation that was cleared and re-seeded.**

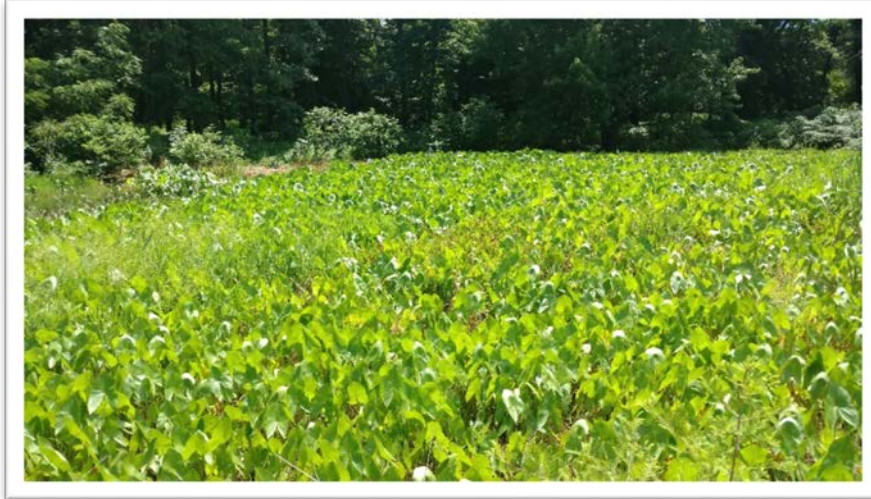
The emergent wetland is proposed for the one existing emergent wetland in the corridor and would also be planned for any wetlands or oxbows that may be created during channel re-construction (Figure 72).

**Figure 72: Restored emergent wetland with large populations of arrowhead, water plantain, iris and other species at a native plant nursery in Illinois**

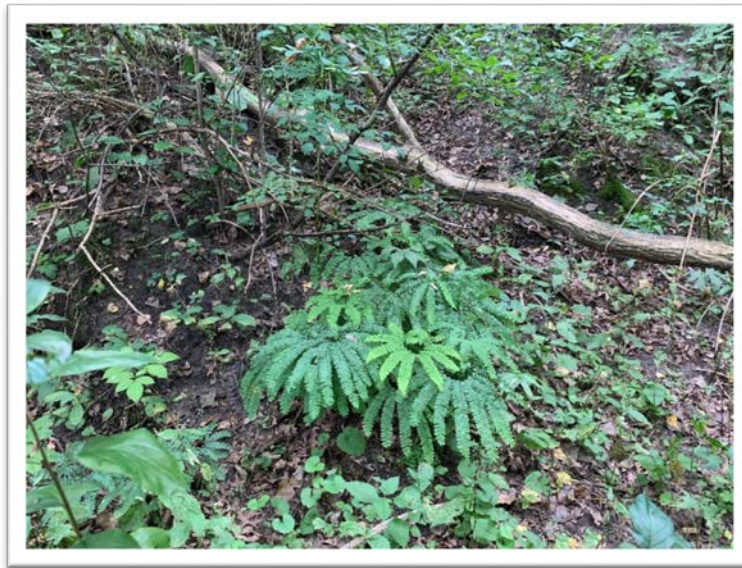
The mesic woodland restoration would be proposed for north-facing, shadier areas that would harbor more shade-tolerant woodland species. When doing the site survey, a number of remnant species were noted, such as maiden hair fern and alternate-leaved dogwood (Figure 74). Clearing and managing of invasive species would be the main restoration action required here. With adaptive management of invasive species, we would hope to stimulate the native species already present.

**Figure 74: Alternate-leaved dogwood growing in the corridor, getting overtaken by invasive shrubs.**

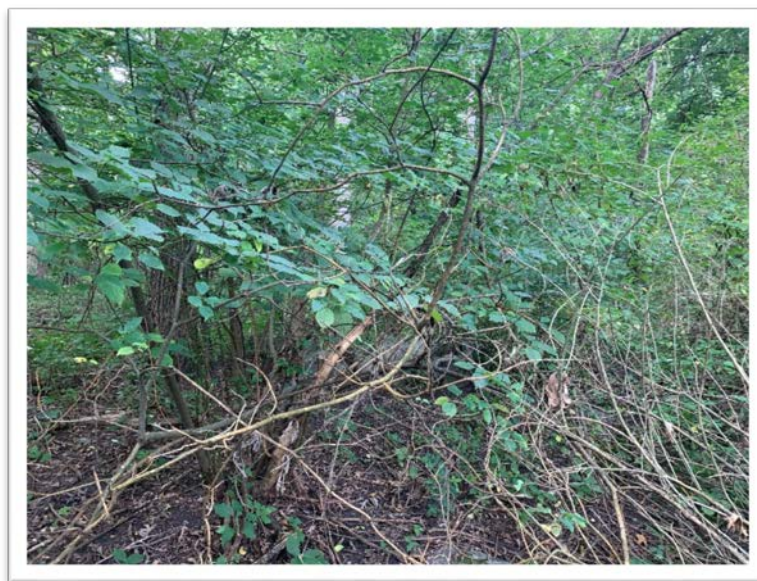
Clearing and managing of invasive species would be the main restoration action required here. With adaptive management of invasive species, we would hope to stimulate the native species already present (Figure 75).

**Figure 75: Photo of invasive shrubs within the Pheasant Branch Corridor**

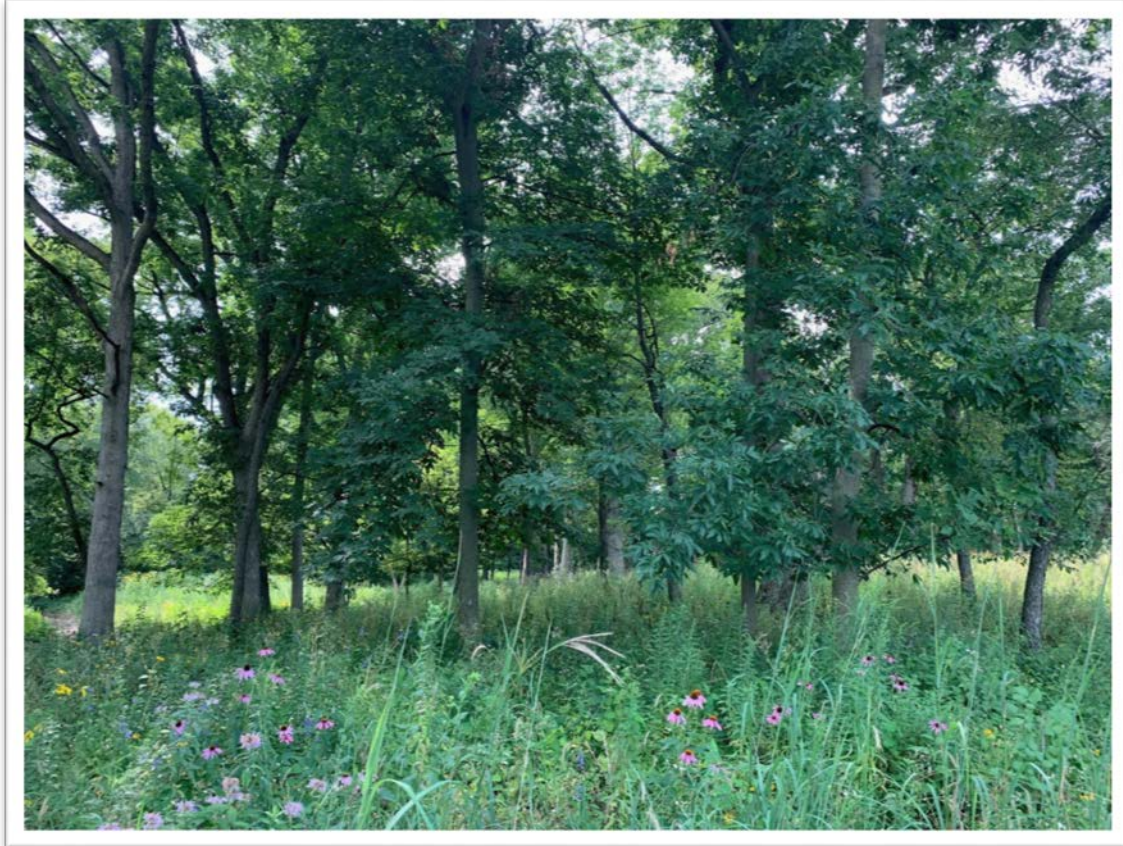
The oak savanna is the largest area of proposed restoration within the corridor. Most of the upland areas within the corridor could be restored to oak savanna (Figure 76).

**Figure 76: Restored oak savanna two years after woody clearing and seeding. Area will be managed with prescribed fire and invasive control. Note the herbaceous cover and diversity**

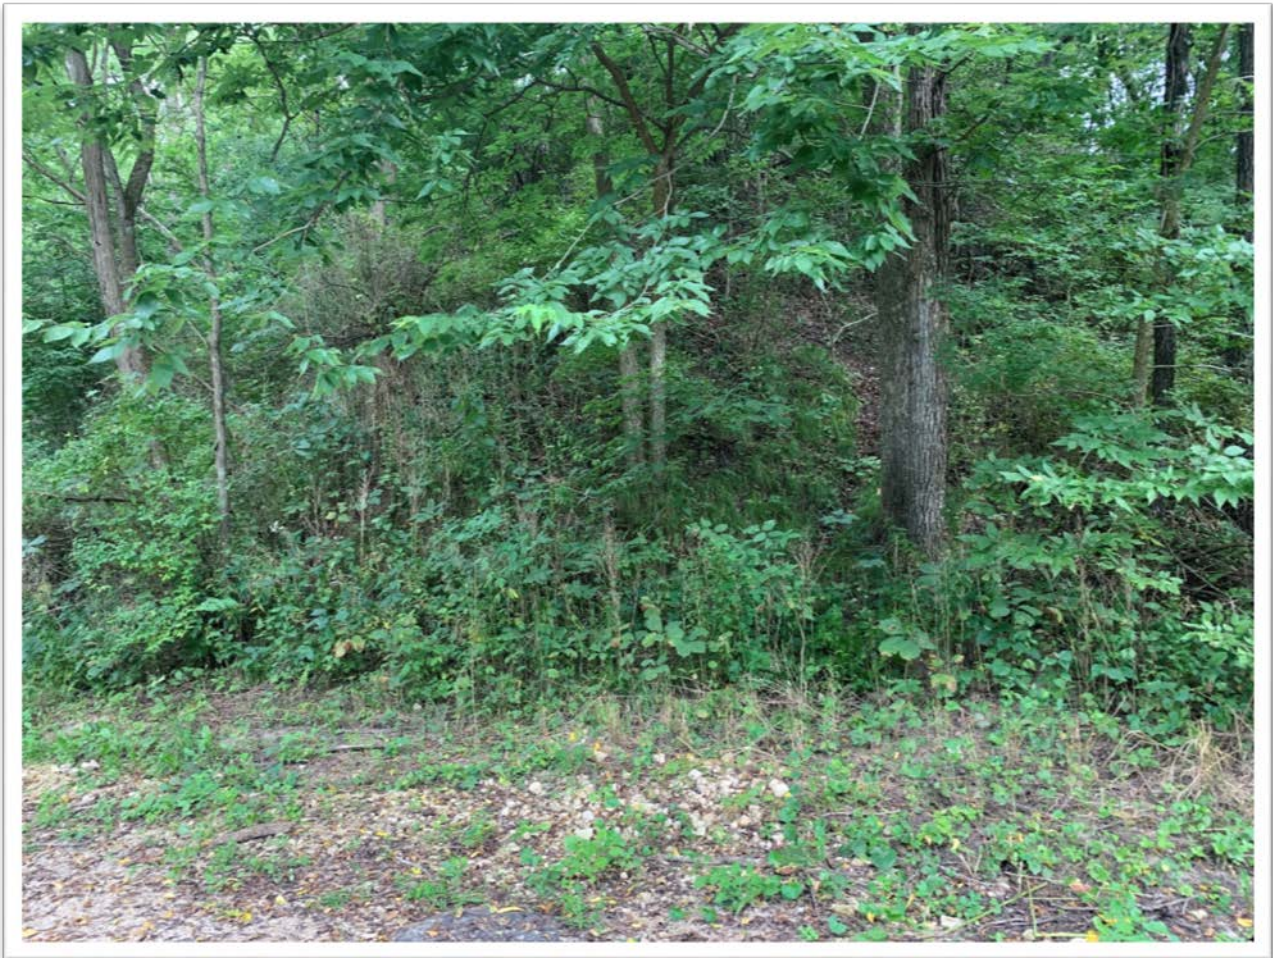
There are many canopy oak trees with large infestations of invasive trees and shrubs underneath them. There is very little sunlight reaching the ground in these areas, preventing oak regeneration and lowering overall diversity. This also exacerbates erosion as there is very little groundcover at all underneath the canopy.

Restoration would entail clearing invasive trees and shrubs to allow sunlight to reach the ground to stimulate the herbaceous understory and oak regeneration. Herbaceous invasive species such as garlic mustard and dame's rocket will also need to be controlled as part of this restoration area. Re-seeding would also be proposed to increase herbaceous diversity. These areas could be managed by prescribed fire to control woody invasive species and stimulate native herbaceous cover (Figure 77).

**Figure 77: Overgrown knoll with large over story oaks that would be an ideal candidate for oak savanna restoration in the Pheasant Branch Corridor.**

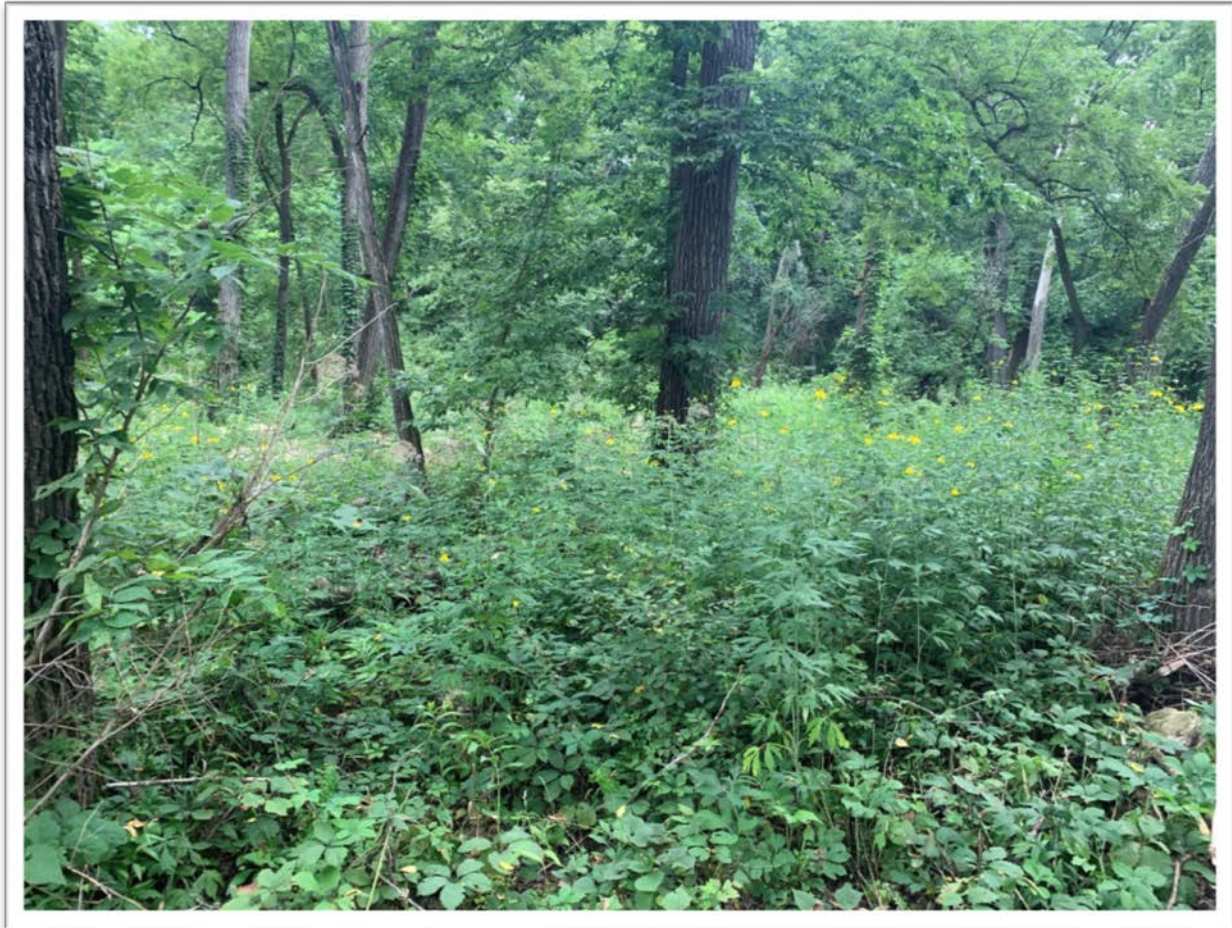
The floodplain restoration refers to the wooded areas directly abutting the creek within the existing floodplain. These areas experienced severe erosion and tree loss during the 2018 flood. This area is currently dominated by large canopy trees such as black walnut, cottonwood and silver maple along with invasive trees like black locust (Figure 78).

Figure 78: Native herbaceous floodplain vegetation thriving where some sunlight can reach the ground. Further clearing along with re-seeding and other restoration would stimulate regeneration of native herbs

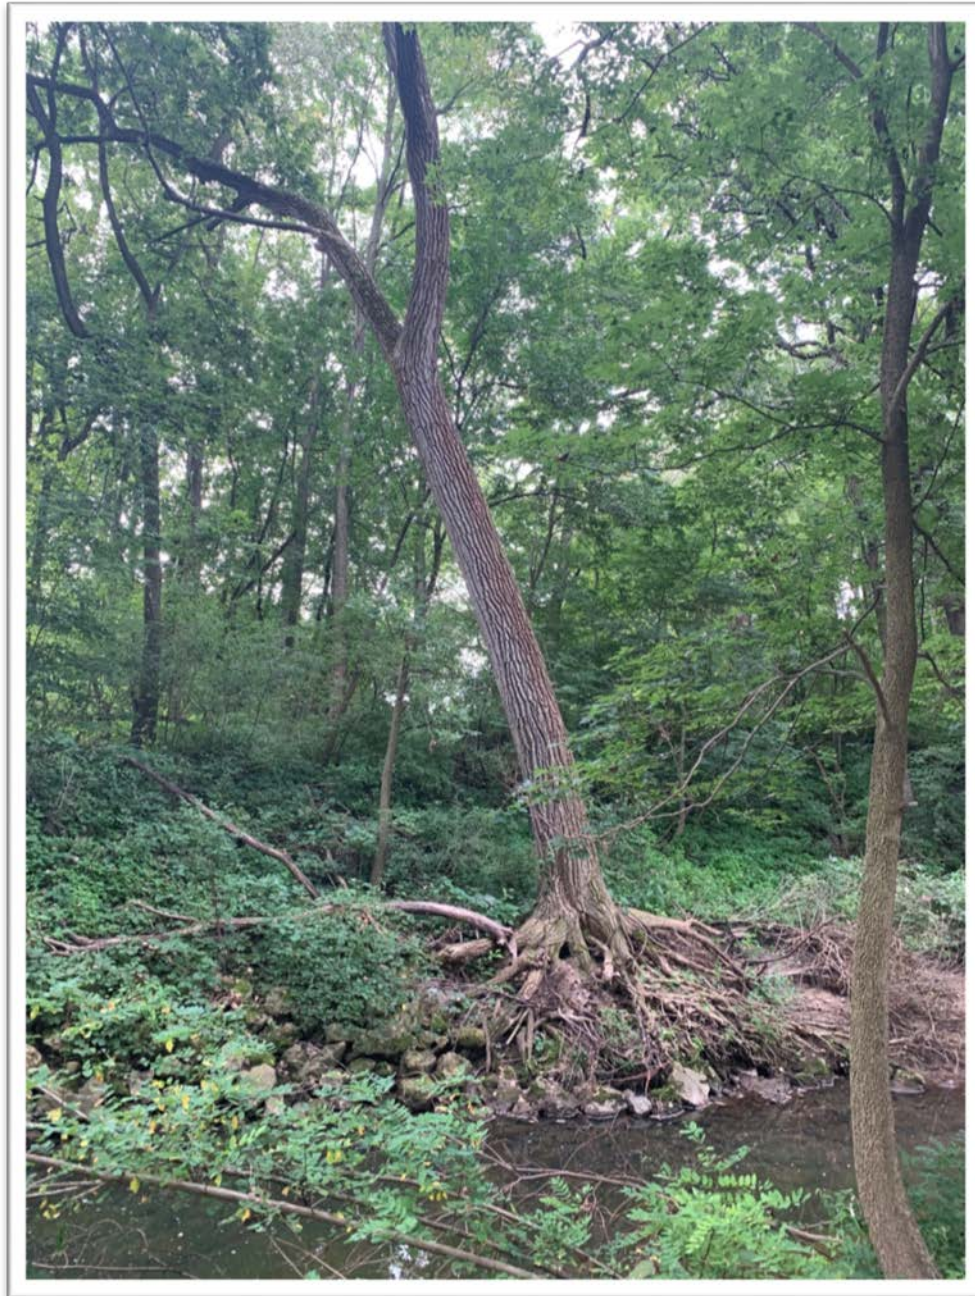
Clearing trees (especially invasive species such as black locust) will be necessary to aid in stormwater conveyance but will also provide an opportunity to restore the native herbaceous community, shrub layer and stimulate oak regeneration. Herbaceous invasive species such as garlic mustard and dame’s rocket will also need to be controlled as part of this restoration area (Figure 79).

**Figure 79: Example of a compromised tree that will eventually fall into the stream and potentially become hazardous debris during a flood event. Clearing some trees from the corridor will reduce the damage caused by debris in high flows**
